*by Cathy J. Wendt and Hollis H. Allen*

Wendt, C. J., and Allen, H. H. (2001). "Archaeological site and reservoir shoreline stabilization using wetland plants and bioengineering, Rice Reservoir, Wisconsin," *Water Quality Technical Notes Collection* (ERDC WQTN-CS-02), U.S. Army Engineer Research and Development Center, Vicksburg, MS.  
[www.wes.army.mil/el/elpubs/wqtncont.html](http://www.wes.army.mil/el/elpubs/wqtncont.html)

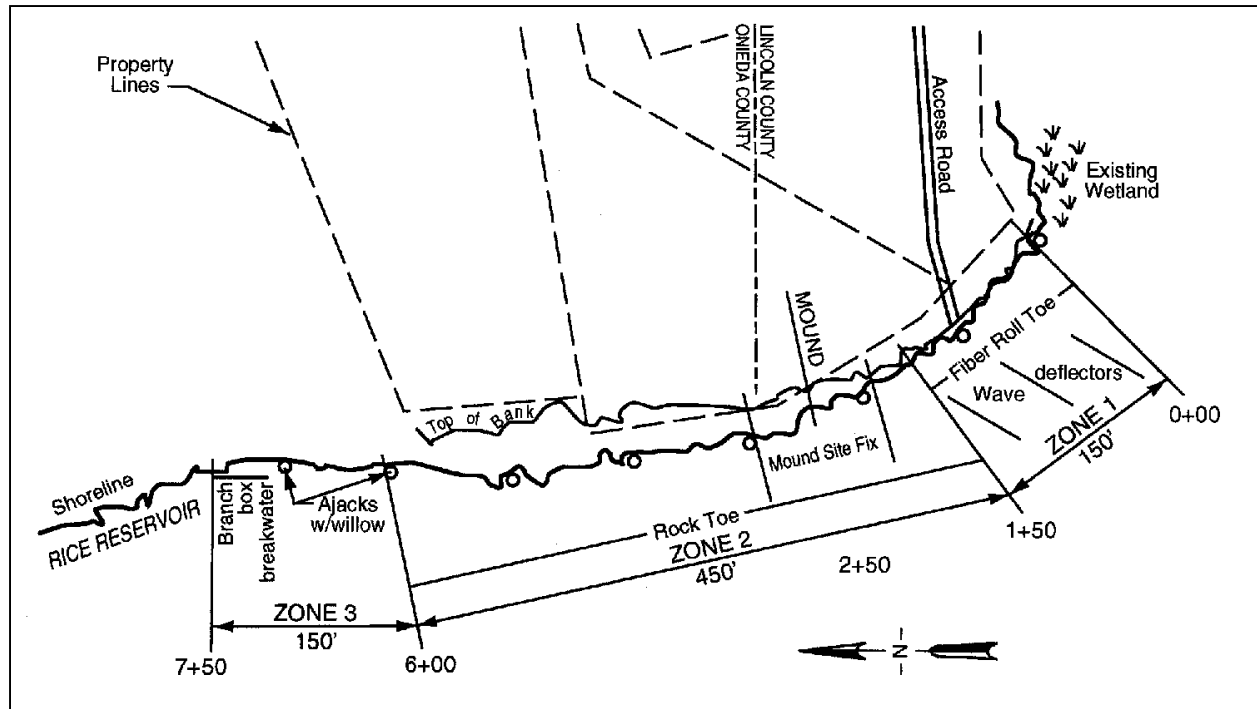
Figure 2. Zones of eroded shoreline and installed measures

- **Zone 1** - The southern 45-m (150-ft) section varied in bank height from 0 to 4 m (0 to 12 ft). A natural wetland exists around the point at the south end. This zone had vertical, lower banks that required less protection.

- **Zone 2** - The middle 14-m (450- ft) section was the most severely eroded. Bank heights varied from 4 m to more than 9 m (12 to 30 ft) with an average slope of 1.5(h):1(v). This zone required installation of a hard toe and stabilization of the face of the bank.

- **Zone 3** - The northern 45-m (150-ft) section had the least amount of active erosion. The face of the bank in this area was fully vegetated with red and white pine, white birch, oak, aspen, shrubs, and herbaceous plants. Bank height varied from 0 to 6 m (0 to 20 ft) and the only erosion evident was an undercut lip at the toe of the bank. This zone required methods where no disturbance of the bank would occur. Protection was added at the toe to attenuate wave action that threatened the semi-stable area.

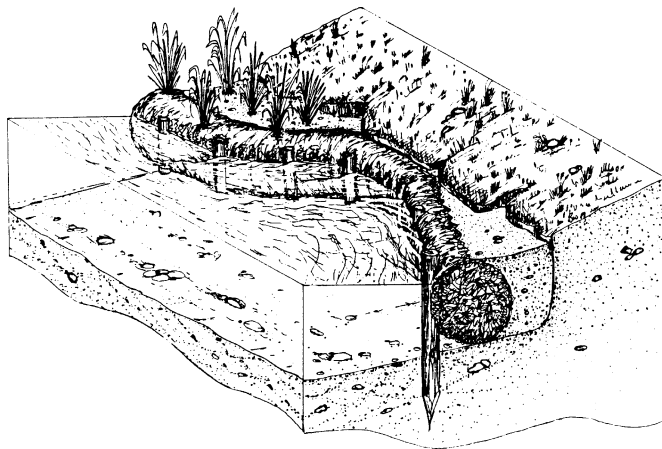
Figure 3. Fiber roll toe

**Fiber Roll Installation.** Four 30-cm- (12-in.-) diameter and three 40-cm- (16-in.-) diameter fiber rolls were installed. Their configuration varied with the shape and height of the bank. A single 30-cm- (12-in.-) diameter roll was used where the bank was lowest and was positioned to "fit" under the lip of the existing undercut bank (Figure 3). As the height of the bank increased, fiber rolls were placed two and three high, resulting in a tiered structure. The fiber rolls were anchored in place with 1- to 1.2-m - (3- to 4-ft-) long wooden construction stakes made of 2 by 4's cut diagonally to form a longitudinal taper.

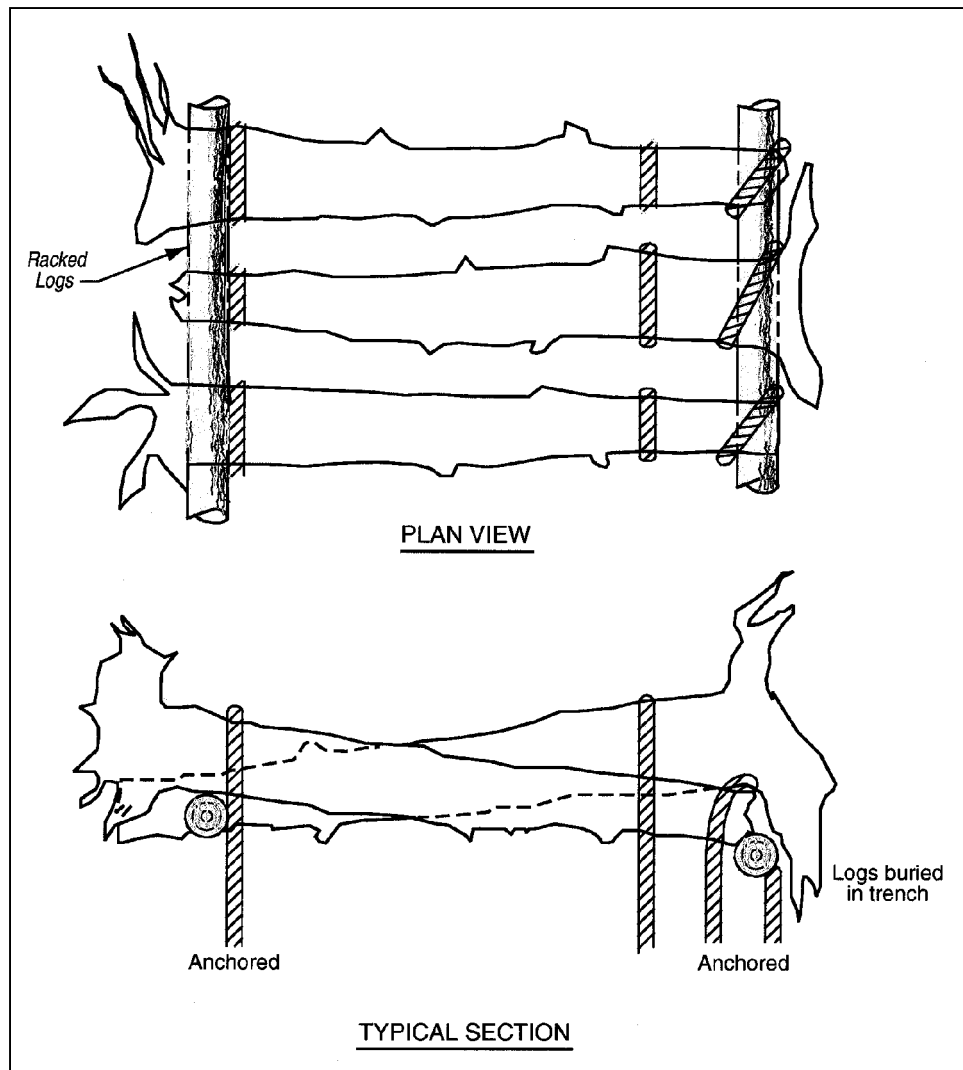
Figure 4. Anchored log wave deflector

**Zone 1 Wave Deflector Performance.** The wave deflectors failed within 5 months of installation. The precise cause of the failure was not documented or observed, but it appears that at a partial drawdown level, the wave action undermined the bottom crosspieces. When the water level again rose, it apparently floated the loosened crosspieces away, allowing the large trees they supported to buoy up and down with the waves, thereby loosening the anchoring system. The wave deflectors were removed entirely after the anchoring system failed.

**Wave Deflector Installation.** Three to four large trees were stacked with alternating butt ends together (Figure 4) at approximately 30 deg perpendicular to the shoreline. The trees were

placed on top of two pieces of 25- to 30-cm- (10- to 12-in.-) diameter red pine partially buried in the reservoir bottom and lying perpendicular to the trees. The trees were cabled in place using Duckbill® anchors. The wave deflectors were placed to block waves from northerly and northwesterly winds. The Duckbill® anchors were driven into the reservoir bottom, leaving only the portion of the cable connecting the trees exposed.

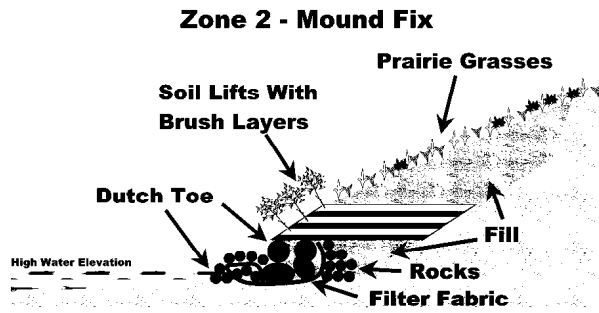
Figure 5. Mound site fix

**Top Bank Treatment.** Two variations were utilized. The critical area near the mound was filled above the vegetated geogrid to the top of the bank (Figure 5). The area was then hydroseeded with prairie grasses (*Elymus canadensis*, *Andropogon gerardi*, *Schizachyrium scoparium*, *Bouteloua curtipendula*, and *Sorghastrum nutans*) and covered with an Excelsior®

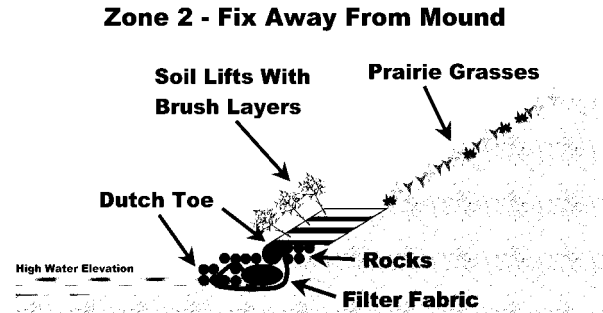
Figure 6. Fix away from mound area

erosion control blanket. The amount of fill was gradually reduced as the distance from the mound increased, thereby blending it into the previously existing bank configuration as illustrated in Figure 6. Where it was not already vegetated, the bank away from the mound area was hydroseeded with the same species of prairie grasses as listed above.

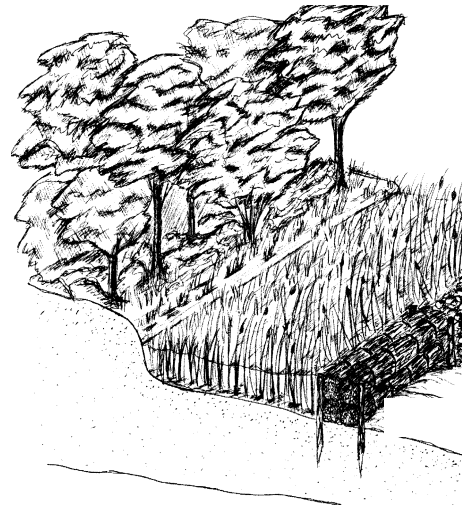
Figure 7. Branchbox breakwater lakeward of protected wetland plants

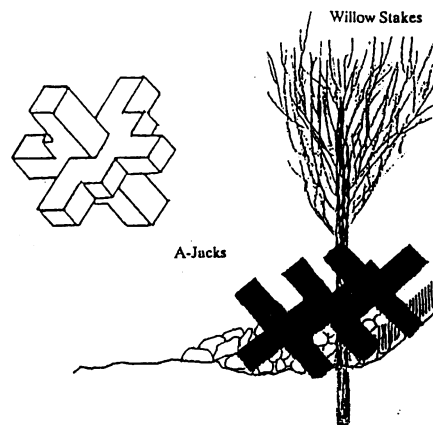
Figure 8. A-Jacks® toe

**A-Jacks® Installation.** The A-Jacks® were installed during the April workshop. They were placed in rows so that each A-Jacks® unit interlocked within each row and with the units in adjacent rows (Figure 8). Each A-Jacks® unit, when installed, has three 60-cm (24-in.) axes forming six 30-cm (12-in.) legs. The lowest rows of A-Jacks® were trenched in close to the base of the bank. Fibredam® was placed between the rows and in the crevices to reduce soil movement and encourage root growth through the A-Jacks®. Live native willow and dogwood cuttings were jetted into the structures in April. Pre-rooted willows (USFS stock) were planted between the A-Jacks® and the toe of the bank in mid-August. The A-Jacks® were backfilled in September with a soil/rock mixture.

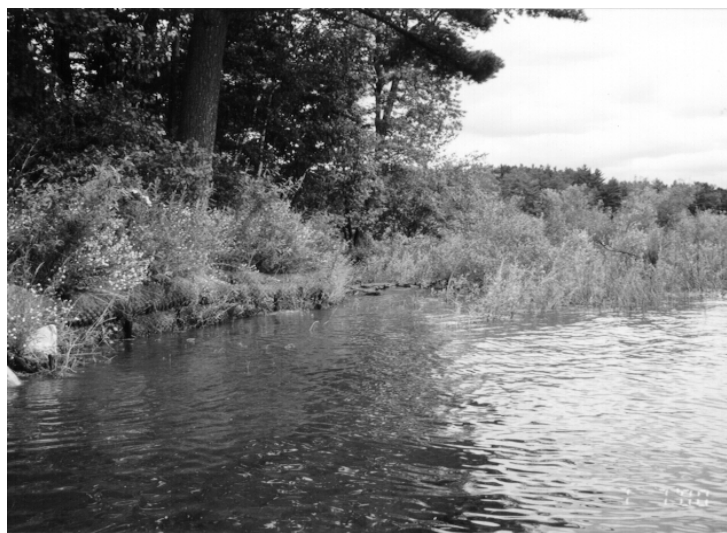
Figure 9. Zone 1, July 7, 2000

In Zone 1, the fiber rolls have remained intact (Figure 9) with an added benefit of providing wildlife habitat. Burrowing animals, primarily rabbits, excavated and inhabited small

openings behind the fiber rolls. These openings do not seem to be compromising the integrity of the structure. The rabbits browsed much of the willow over winter that had been planted as cuttings behind and between the fiber rolls. Despite the browsing, the willow resprouted. Of the 20 rooted willows (USFS stock) that were planted, 10 have survived.

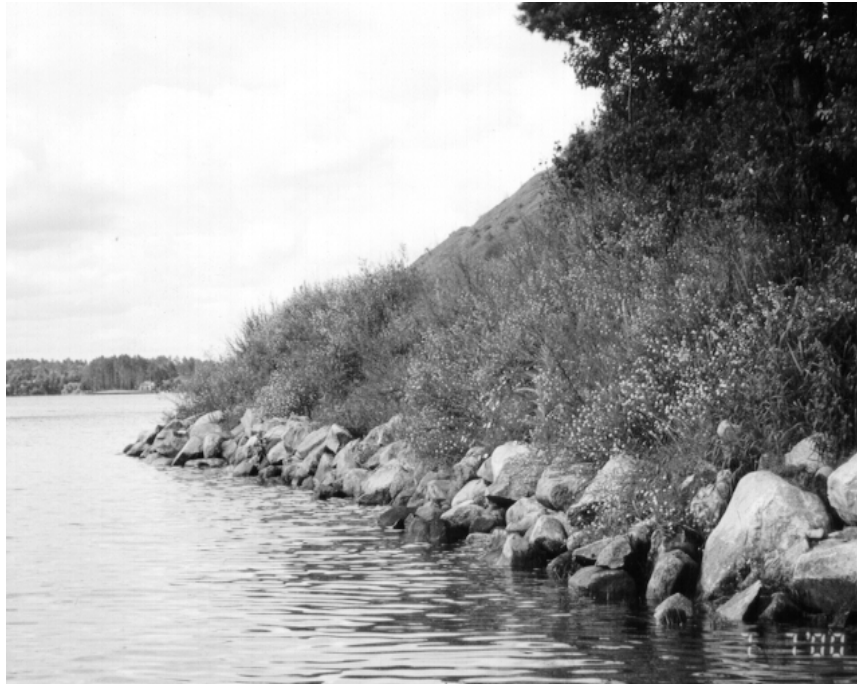
Figure 10. Zone 2, July 7, 2000

**Zone 2 Rock Toe Performance.** The rock toe has performed as expected for the majority of the zone (Figure 10). Soon after completion, however, the reservoir level rose and a void was created behind the large rocks, causing 1.5 lin m (5 lin ft) of soil lifts to collapse. Filling this area with small rock repaired the void and no further erosion has occurred in this area.

Additional smaller areas (1-2 m<sup>3</sup> or 11-22 ft<sup>2</sup> each) have also washed out, but no major problems seem to have been created by these voids. As a preventative measure, these new voids could be filled, but the voids seem to have limited themselves and our intent is to monitor them to see if they will be “self-healing.” All of the voids are located away from the mound. It appears that the reduced level of armoring in the fix away from the mound may be contributing to these minor failures. No failures have occurred in the mound fix area.

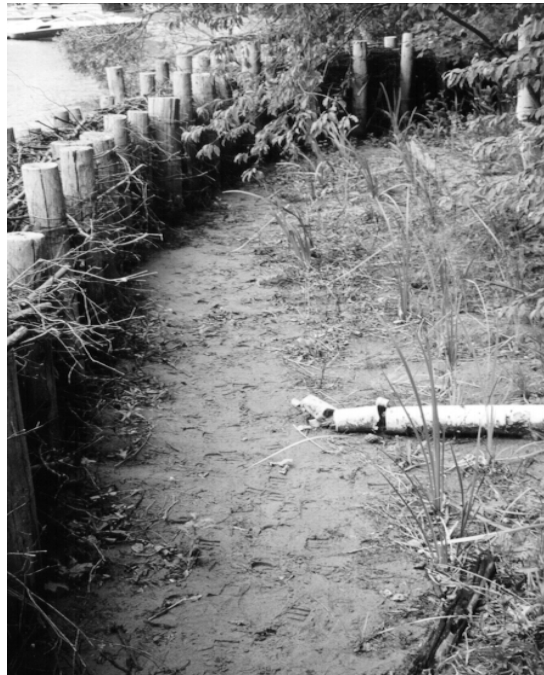
**Zone 3 Branchbox Performance.** The branchbox breakwater is providing limited habitat for emergent plants (Figure 14). The habitat is limited because Wisconsin laws prohibit most structures from being more than a few feet away from the shore. The Wisconsin Department of Natural Resources did, however, allow this structure for demonstration purposes, but only allowed it to extend 4.5 m (15 ft) from the shore. This is still short of the more typical placements of 10 m (33 ft) or more.

Figure 14. Area behind branchbox breakwater

It appears that the area between the branchbox and shore may have suffered from either or both of two effects created by the branchbox's proximity to the bank. First, the protected area is shaded by existing trees on the steep bank for half of the day, then is shaded by the branchbox breakwater for much of the remainder of the day. This lack of sunlight may be responsible for an observed 0.76-m- (2-1/2-ft-) wide area directly behind the branchbox that is unvegetated (Figure 14). Second, sand has deposited behind the branchbox to a height approximately 6 in. higher than directly in front of the branchbox. This sand appeared to be enough to cover small plants as they began to grow. Between this 0.76-m- (2-1/2-ft-) wide void and the original bank, however, there is vegetation. Quadrats were used twice to assess the vegetation of the entire area behind the branchbox breakwater, once on May 17, 2000 and again on July 7, 2000. The entire area was covered with 28 quadrats or partial quadrats. Numbers of *Juncus effusus*, *Scirpus spp.*,

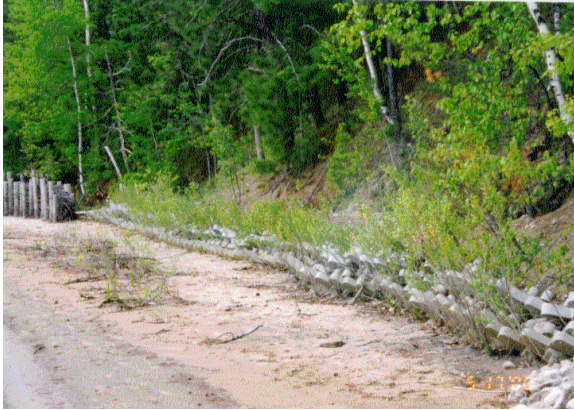
**Zone 3 A-Jacks® Performance.** Due to the heavy vegetation, the A-Jacks® are barely visible from the water. Although the total stem count has decreased (359 stems on July 7, 2000 down from 391 stems on May 16, 2000), the percent area covered is increasing based on visual comparison of photos (Figures 16 and 17). The stem count may have decreased for several possible reasons. First, the water level of the reservoir was within 3 ft of full by the middle of April, which provided the plants with adequate moisture producing the initial surge of growth indicated by the high stem count for May. Second, from the end of June through early August the water level was within 1 ft of full and some of the individuals may have succumbed to drowning and/or wave action causing abrasion from the A-Jacks®, lowering the overall stem count. Third, competition for light and nutrients between individual plants may have been a source of mortality.

Figure 16. A-Jacks® willow coverage, May 2000

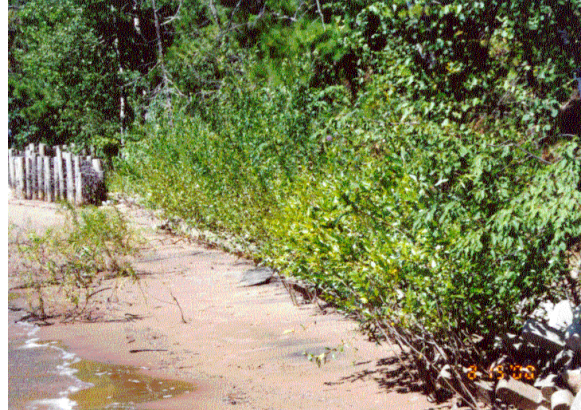
Figure 17. A-Jacks® willow coverage, July 2000
