Bioengineering as a Tool for Restoring Ecological Integrity to the Carson River

*by Kevin L. Piper, J. Chris Hoag, Hollis H. Allen,
Gail Durham, J. Craig Fischenich, and Robert O. Anderson*

PURPOSE: This technical note describes a case study involving the following: (a) use of bioengineering (a combination of vegetation and engineered structures and materials) and rock structures to restore an eroded bank of the Carson River, Nevada, and (b) restoration of ecological amenities that existed prior to disturbances by man and a major flood event.

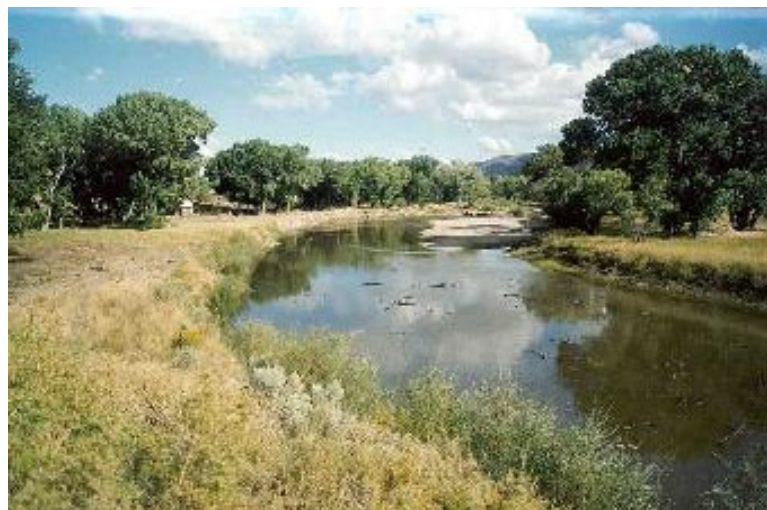
Figure 2. Carson River bendway site in background (left side of photo) prior to any bioengineering treatments

This partnership decided that one damaged bendway with banks that had been cut back 15 or more ft (4.5 m) by the flood would serve as a site to focus a classroom workshop and follow-up demonstration of various erosion control and habitat improvement treatments (Figure 1). The demonstration site was next to residences whose back yards or fields had been eroded along with adjacent riparian vegetation (Figure 2). The flood caused this erosion, but the effects were exacerbated by management activities, such as mowing immediately adjacent to the streambank. The lack of vegetation and storm-caused erosion contributed to a lack of ecological amenities in the riparian zone, e.g., lack of habitat, increased sediment loads, increased water temperatures, and other water quality parameters.

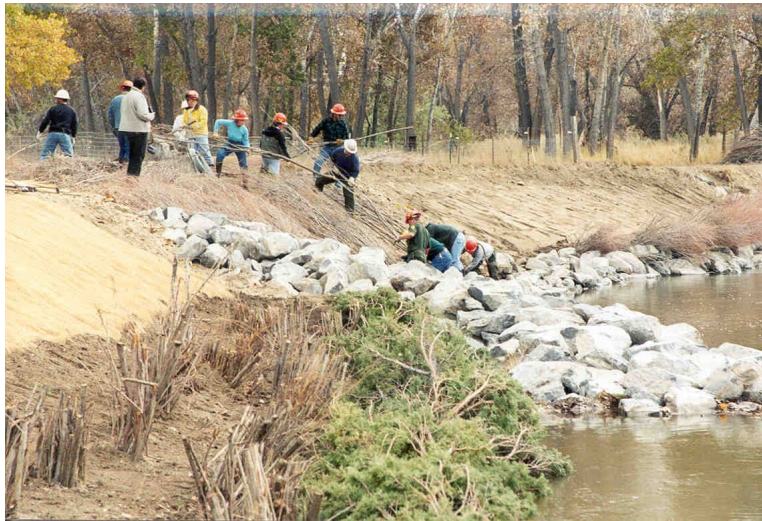
Figure 6. Three bioengineering treatments: (a) live willow clumps with a juniper tree revetment (foreground); (b) workshop attendees installing brush mattress with rock toe protection (middle of photo); (c) brush layering over peaked stone dike (far right of photo). Erosion control fabric with seeded riparian grasses appears on upper bank on left side of photo

protection between two of the barbs (Figure 6). The fifth bioengineering treatment, called brush layering, was installed using dormant cuttings of willow along the inside face of a peaked stone dike (Figure 6). The area was backfilled after installation and provided immediate overhanging shade and cover of the stream to promote aquatic habitat.

Three of the treatment areas were planted with a mix of native riparian grasses and covered with a commercially produced erosion control fabric (ECF) composed of coconut husk fibers (Figure 6).

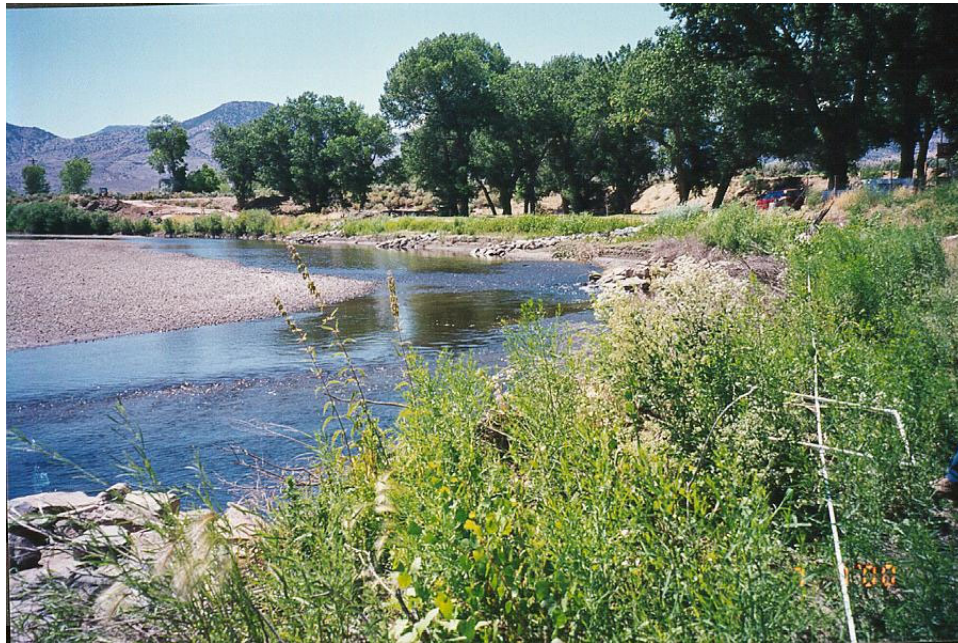
Figure 7. View upriver in August 2000, 21 months after installation of bioengineering treatments; the peaked stone dike with brush layering is shown in foreground
