*by Cathy J. Wendt and Hollis H. Allen*

Wendt, C. J., and Allen, H. H. (2001). "Archaeological site and reservoir shoreline stabilization using wetland plants and bioengineering, Rice Reservoir, Wisconsin," *Water Quality Technical Notes Collection* (ERDC WQTN-CS-02), U.S. Army Engineer Research and Development Center, Vicksburg, MS.  
[www.wes.army.mil/el/elpubs/wqtncont.html](http://www.wes.army.mil/el/elpubs/wqtncont.html)

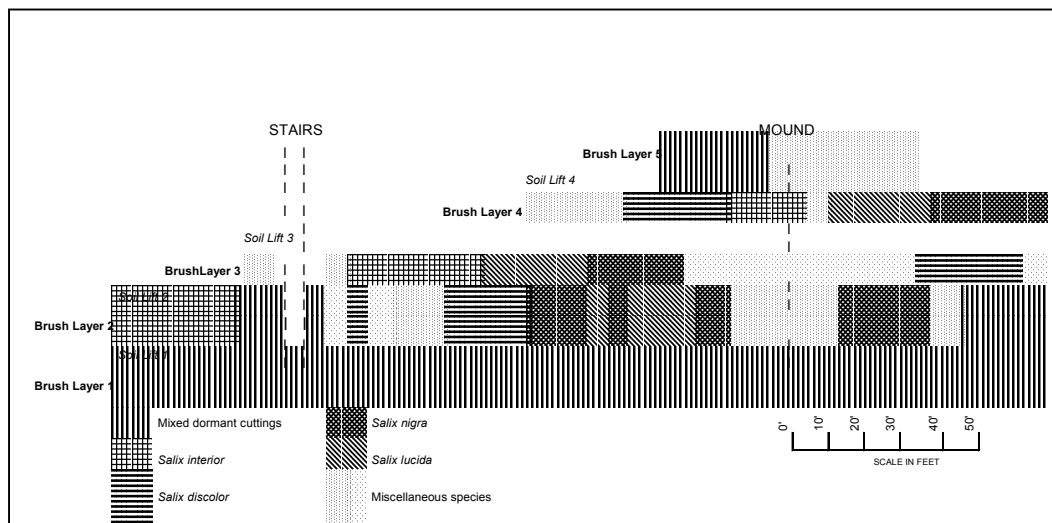
Figure 11. Diagram of brush locations in the geogrid

The transect method determined the survivability of the woody species by measuring 100 percent of the brush layers along transects. Survivability was determined by dividing the living stem occupation along the transect by the linear distance of materials originally planted. Each of the five layers was mapped (Figure 11) according to the species originally planted in the geogrid. Planting dates and harvesting dates were recorded. Portions of each brush layer consisted of different species (some were pre-grown in brush layer mats and some were installed as dormant cuttings). The species pre-grown in the brush layer mats were carefully monitored so valid comparisons between species could be made. The dormant cuttings were not differentiated by species but were intentionally mixed to increase the brush layer’s chance of survival. Five

species of willow and one dogwood, *Cornus stolonifera*, were harvested locally and used in both variations in approximately the same proportions. This provided a means to compare the two planting techniques. Comparing only these six species, the pre-grown brush layer mats resulted in a 41.5-percent overall survival rate, slightly less than the 47-percent survival rate for the same species planted as dormant cuttings.

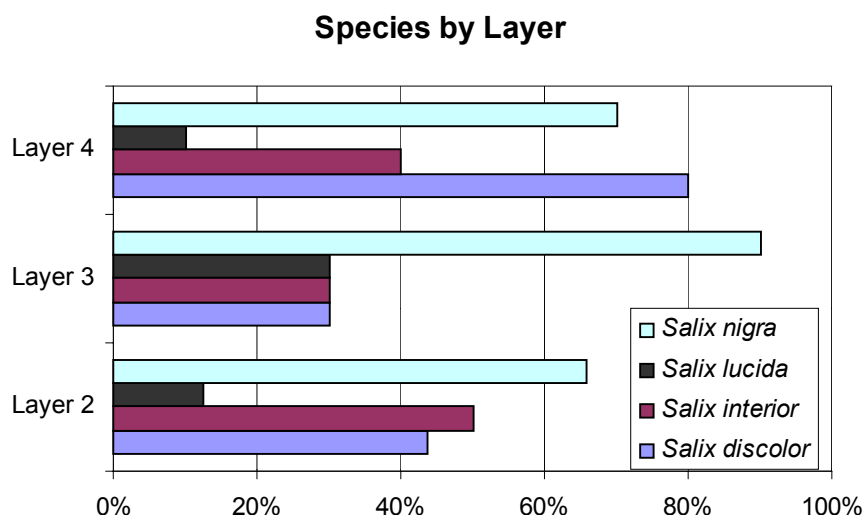
Figure 12. Plant survival by vegetative-geogrid height location by layer

Of the 85 pre-grown brush layer mats, 73 contained the six native species. The placement of the mats on the bank was designed to test survivability of these species (Figure 12) under differing conditions within the site. *Cornus stolonifera* was not included in the comparison since an adequate amount of material could not be located. One native willow species, *Salix rigida*, performed poorly in the greenhouse and was also eliminated from the comparison. The 19 mats containing these two species plus 12 mats containing USFS stock are designated as miscellaneous species on the layout map (Figure 11) and were used to fill in the remaining areas among the four species being tested. The remaining four species demonstrated no apparent advantage or disadvantage to placement on the bank.

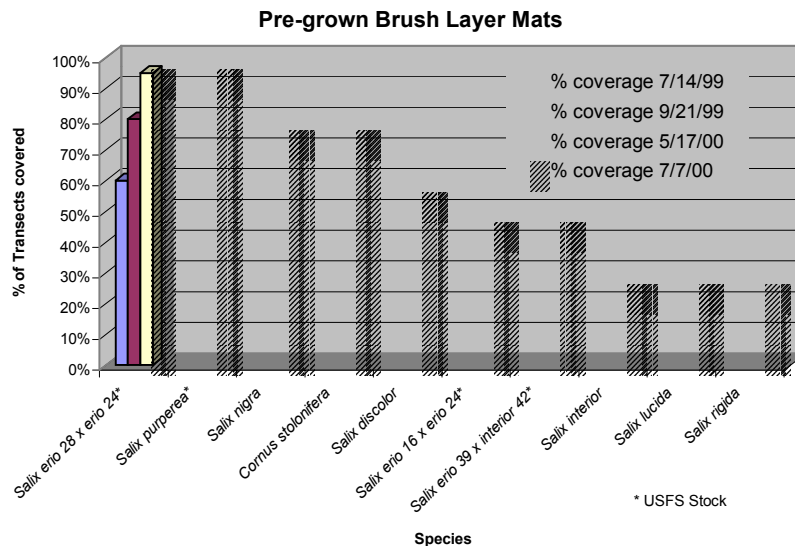
Figure 13. Performance (percent coverage) of brush layer mats by species

The transect method revealed a steady increase in the coverage for each pre-grown mat during the four testing periods from July 14, 1999 to July 7, 2000, with the exception of three mats (Figure 13). For one mat (*Cornus stolonifera*), coverage dropped by 20 percent between May 17, 2000 and July 7, 2000. The other mats were *Salix rigida*, which were already doing poorly in the greenhouse. Some mats showed increases as high as 60-80 percent, with an average increase of 23-percent coverage between July 14, 1999 and July 7, 2000. The species with the highest survival percentages were *Salix eriocephala* (90.0 percent) and *Salix purpurea* (90.1 percent) both from USFS stock. The native locally harvested species with the highest percentages were *Cornus stolonifera* (72.8 percent) and *Salix nigra* (72.7 percent). *Salix lucida* and *Salix rigida* had the lowest survival (17.7 and 16.5 percent, respectively). The overall survival rate of all pre-grown brush layer mats was 46.2 percent.

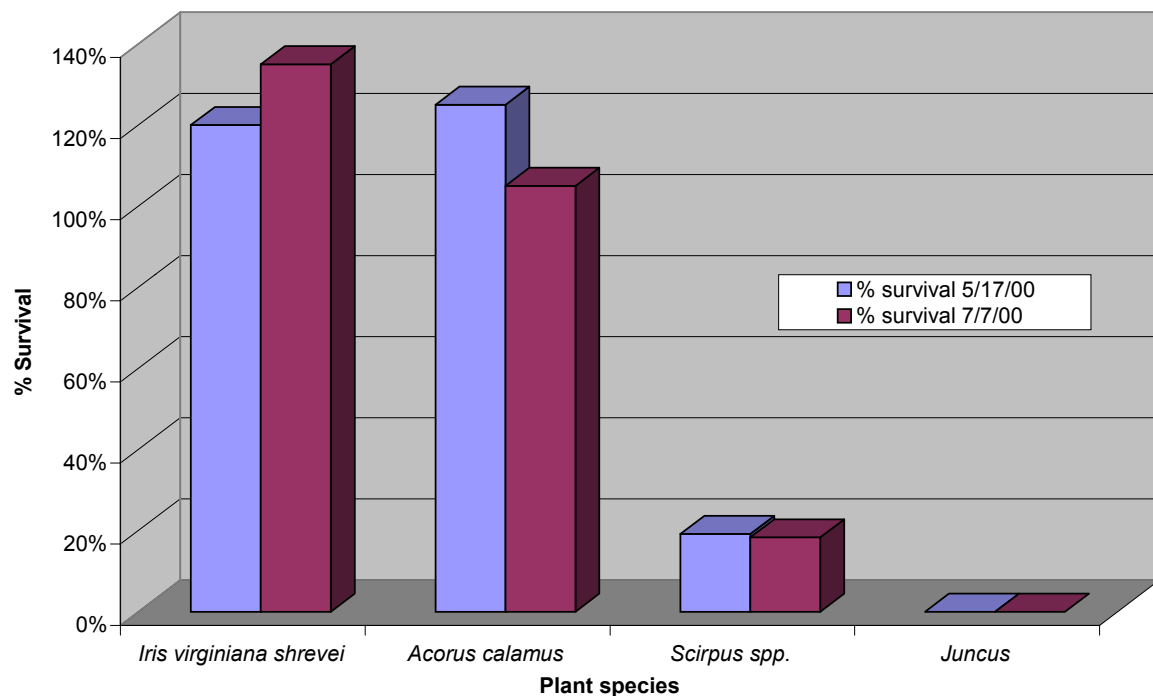
Figure 15. Survival of plants behind the branchbox breakwater

Of the planted species, *Iris versicolor* and *Acorus calamus* had the highest survival percentages when measured on July 7, 2000 (135 percent and 105 percent, respectively) indicating they have already regenerated. *Scirpus spp.* have not fared as well, having a combined survival percentage on July 7, 2000 of 18 percent. Of the 60 *Juncus* that were planted, none survived (Figure 15).
