US Army Corps
of Engineers

Water Quality Technical Note CS-01
May 1995

Tailwater Monitoring During Periods of No Release; Cooper River Rediversion Canal: A Case Study

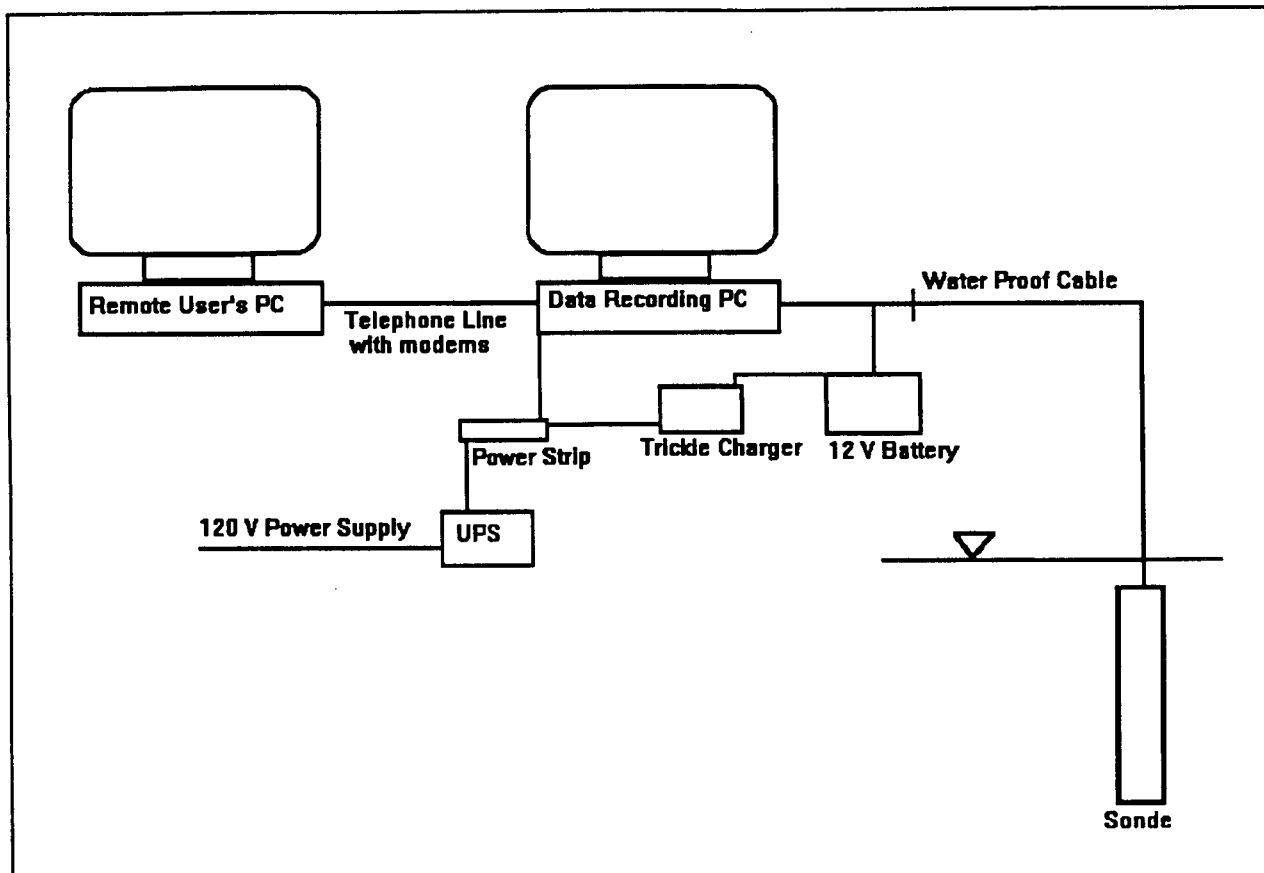
Figure 2. Schematic of typical monitor setup

The monitor system consisted of a water quality sonde, a wet well, and a computer to record data (Figure 2). The wet well, installed on the wing wall on the south side of the tailrace (Figure 3), was constructed of 6-in. schedule-40 polyvinyl chloride pipe. The bottom 10 ft of the pipe had 0.75-in. holes approximately every 2 in. to allow exchange of water. A cap installed on the lower end of the well prevented the sonde from dropping through and possibly becoming entangled.

A Hydrolab H20 water quality sonde (Hydrolab Corporation, Austin, TX) measured temperature, DO, pH, and specific conductivity. The sonde was connected to the powerhouse control room using conduit-encased cable. A waterproof Hydrolab cable was used along the wing wall where there was danger of submersion. Phone line (24-gauge, 4-wire) was used elsewhere. Inside the control room, a 12-V power supply provided power for the sonde. The cable from the sonde interfaced with a dedicated computer located in the resource manager's office via a serial port (RS 232) connection. An uninterruptible power supply (UPS) protected the system from power failure and surges. The sonde was set up, calibrated, and maintained according to standards detailed in the Hydrolab H20 operating manual.

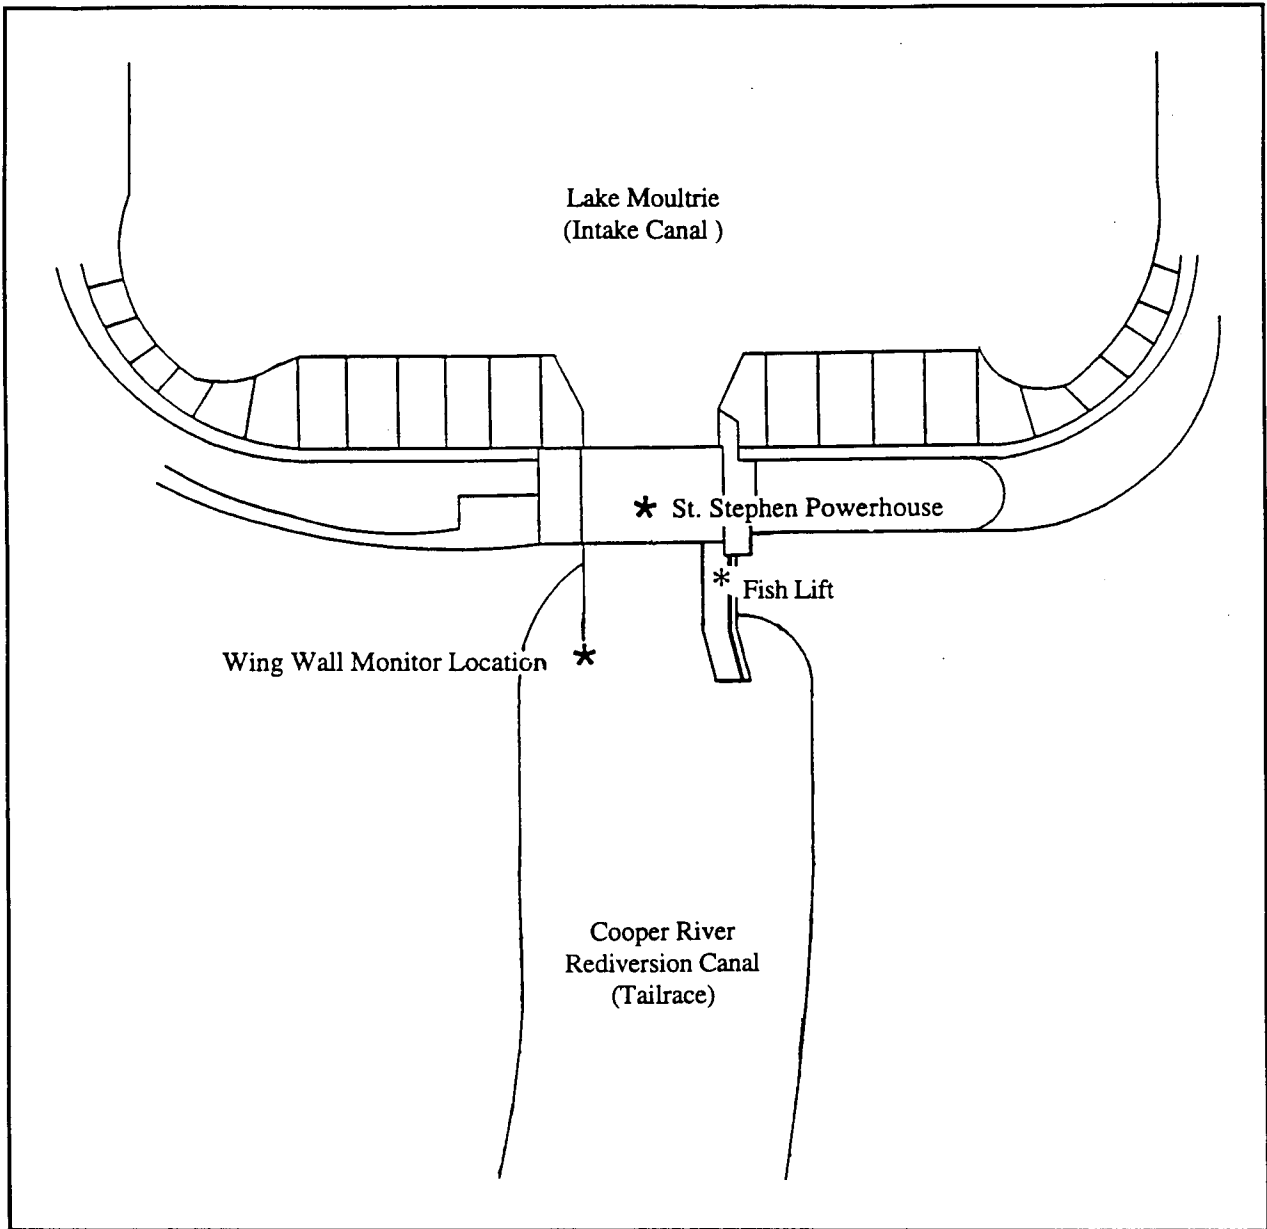
Figure 3. Plan view of St. Stephen dam monitoring site

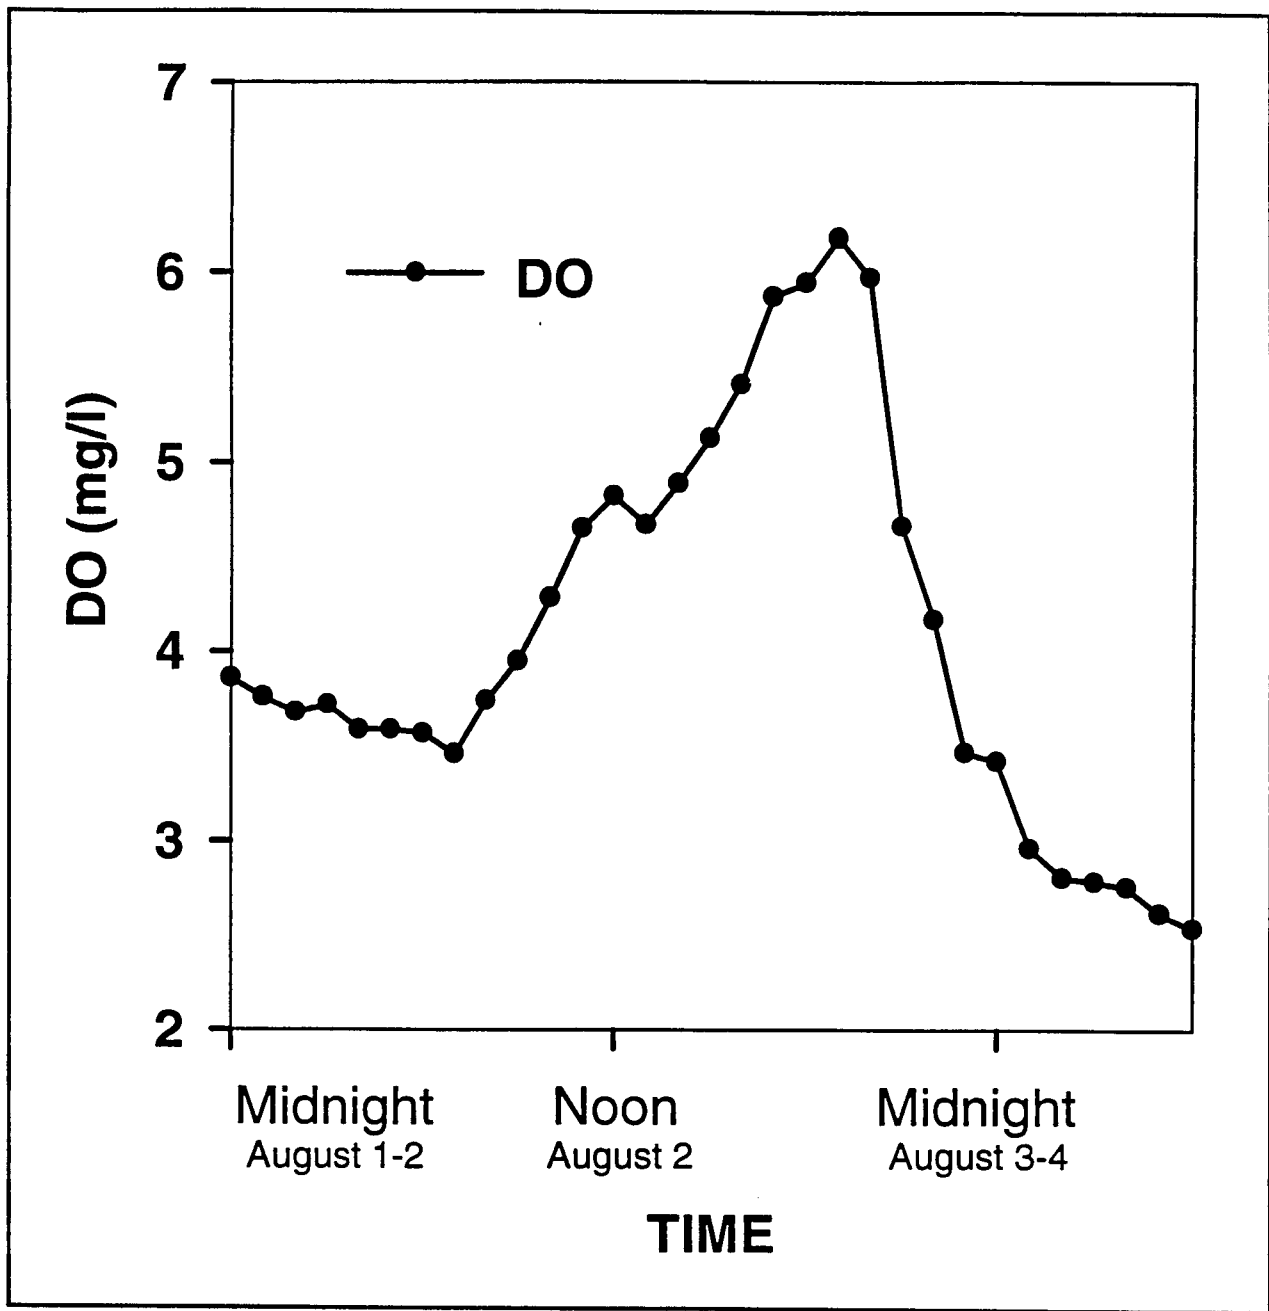
Figure 4. Natural diel variation of dissolved oxygen (during periods of no-release), August 1-4, 1993

The monitor provided a temporal record of DO, temperature, pH, and specific conductivity. A close inspection of this record revealed a diel variation of DO concentration (Figure 4). During periods when releases had not occurred for several days, natural variations of DO concentration greater than 3.5 mg/L in a 12-hr period were observed. Variations were due to photosynthesis increasing DO concentrations during daylight hours and respiration decreasing DO concentrations at night.

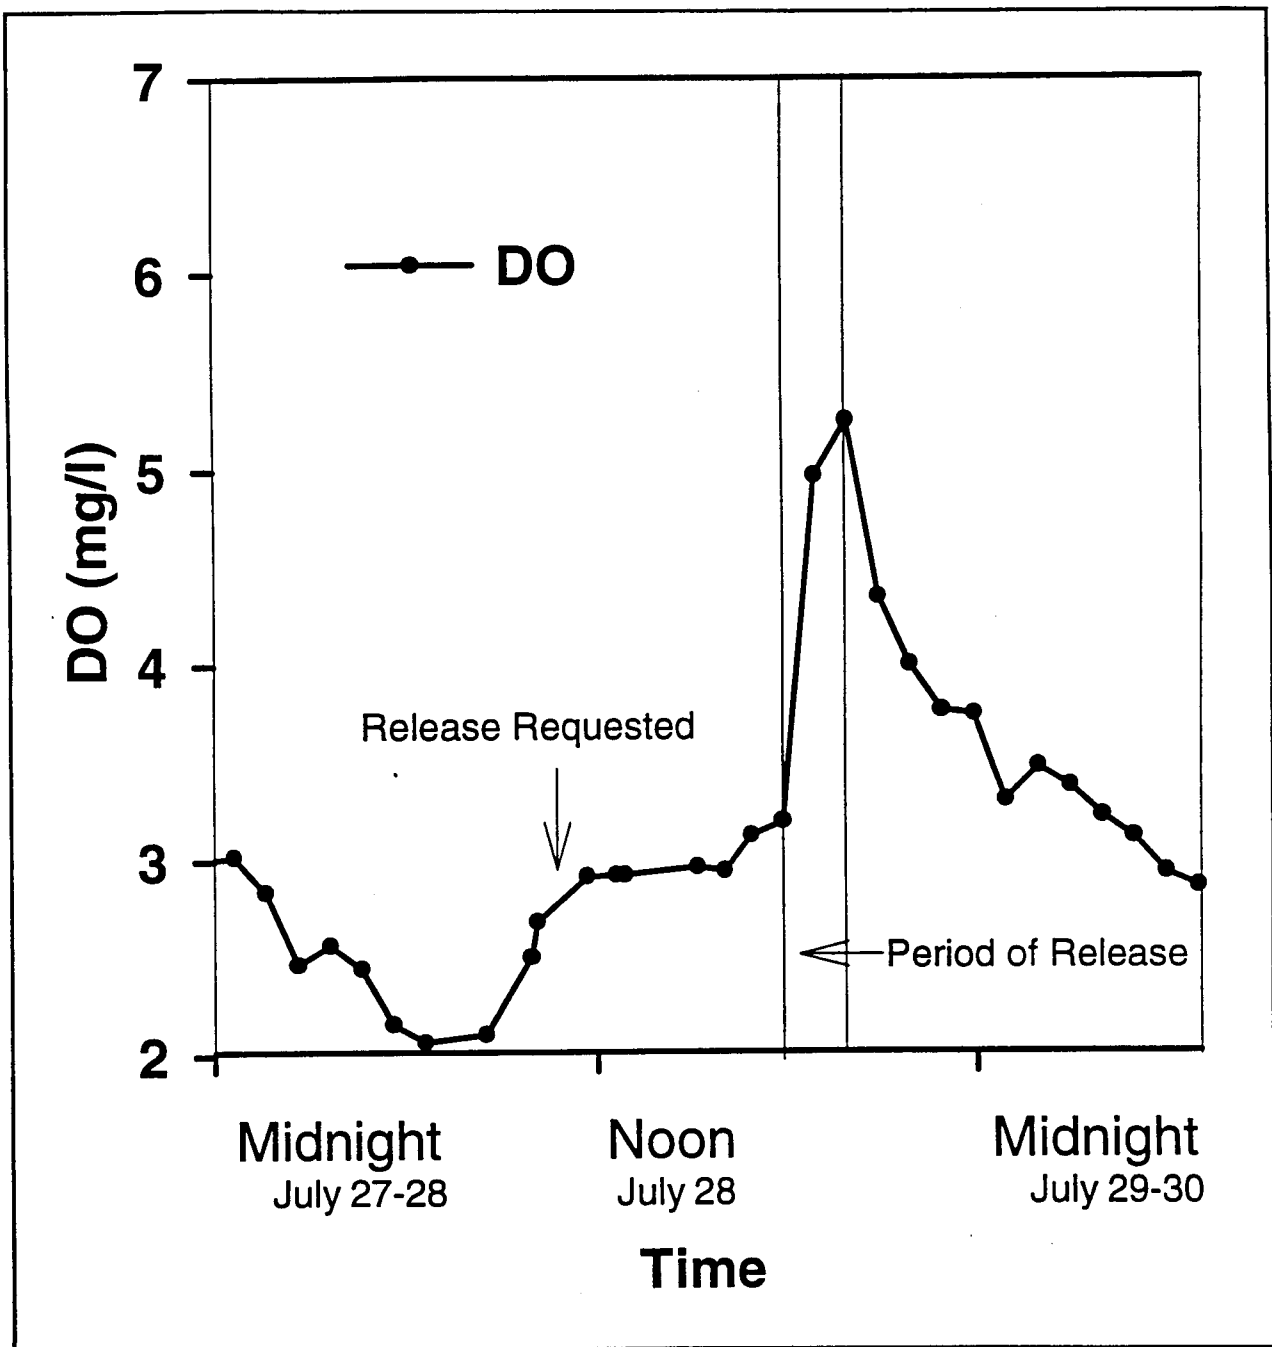
Figure 5. Release to enhance water quality, July 1993

Noting this variation, the Charleston District adopted a release criterion of requiring the release of water whenever the DO concentration dropped below 3.0 mg/L for 8 hr or longer (Figure 5). This decreased the number of water quality-enhancing releases
